Efficacy of a resin-modified glass ionomer varnish in the prevention of tooth enamel demineralization around orthodontic brackets: an *in vitro* study

Invest Clin 2017; 58(4): 365 - 375

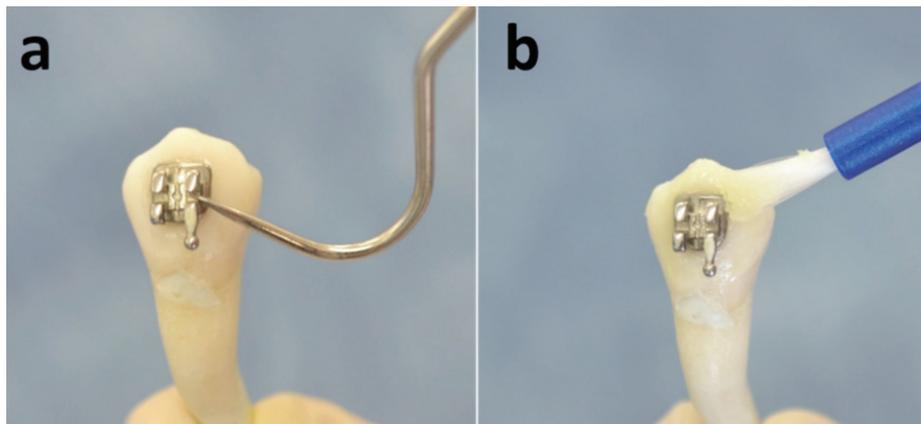
Fig.1. Procedure. a) Cemented bracket with the direct technique. b) Application of glass ionomer varnish.

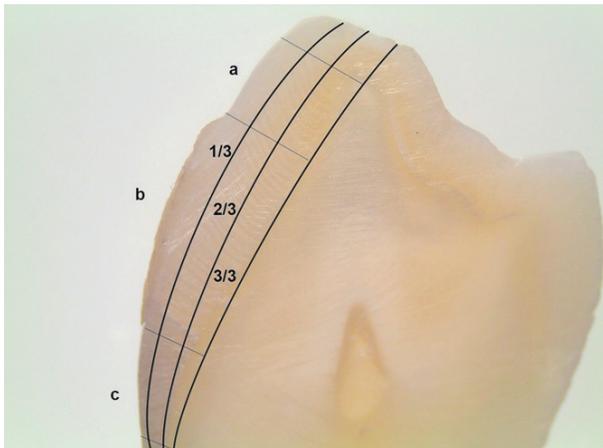
Fig.2. Zones assessed on the buccal aspect of the dental organ: a. occlusal third, b. medial third and c. cervical third. The depth of penetration was evaluated by thirds of the enamel thickness (1/3, 2/3 and 3/3).

from the stereoscopic microscope, restricting the measurements to three zones regarding the bracket's placement on the tooth: a) 2 mm of the occlusal third, b) on the medial third (where the bracket was placed) and c) 2 mm of the cervical third. The scale used to measure the depth of penetration (demineralization) is explained as follows: 0. - Represents no penetration of methylene blue. 1. - Represents a penetration of methylene blue of 1/3 of the enamel's width (from the enamel surface to the dentin). 2. - Represents a penetration of methylene blue of 2/3 of the enamel's width (from the enamel surface to the dentin). 3. - Represents a penetration of methylene blue of 3/3 of the enamel's width (the entire thickness of the enamel) (Fig. 2). The data was submitted to the data collection form, it was then analyzed using the software Minitab version 17(Pennsylvania, USA).

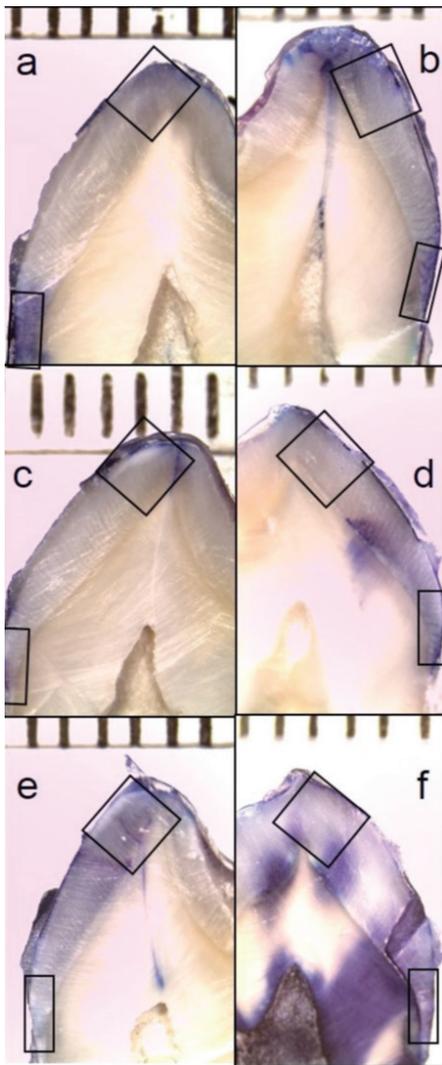
Fig.3. a) Penetration of methylene blue in occlusal third in a representative sample of Group A. b) Penetration of methylene blue in occlusal third in a representative sample of Group B. c) Penetration of methylene blue in medial third in a representative sample of Group A. d) Penetration of methylene blue in medial third in a representative sample of Group B. e) Penetration of methylene blue in cervical third in a representative sample of Group A. f) Penetration of methylene blue in cervical third in a representative sample of Group B. All samples were randomly selected.

A higher penetration of methylene blue (therefore, a greater demineralization) was observed in the dental organs untreated with the Clinpro™ XT varnish compared to the group where it was applied (Fig. 3). By comparing the thirds in every zone of the buccal surface, a greater percentage of demineralization was found in the cervical third of the crown. A Student's t test was performed to find the mean and standard deviation of the measurements performed in the occlusal third, the middle third and the cervical third in each tooth. A higher significance was observed in the cervical third $p \leq 0.0001$ compared to the middle third $p \leq 0.05$ and the occlusal third $p \leq 0.03$ (Table III, Fig. 4 and 5).

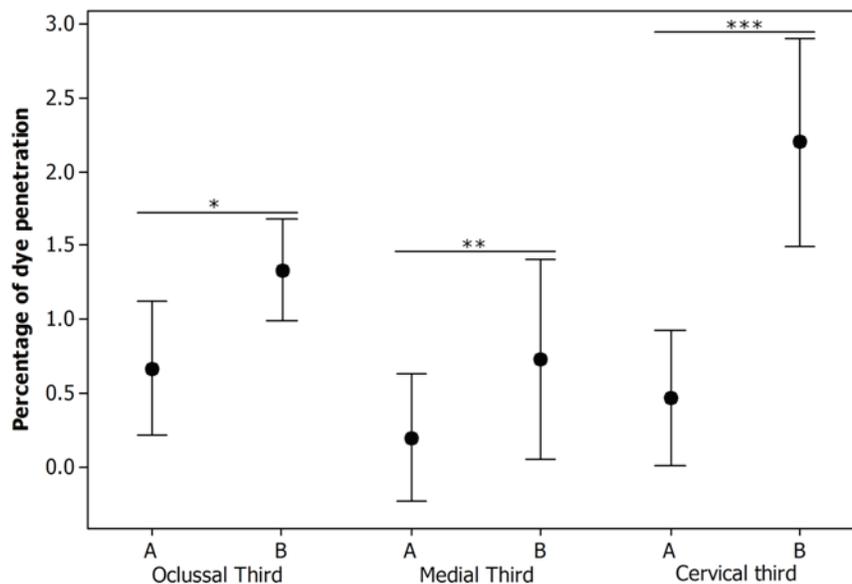
Fig.4. Percentage of methylene blue dye penetration into the enamel by thirds in Group A (A) and Group B (B).
*p≤0.03, **p≤0.05, ***p≤0.0001.

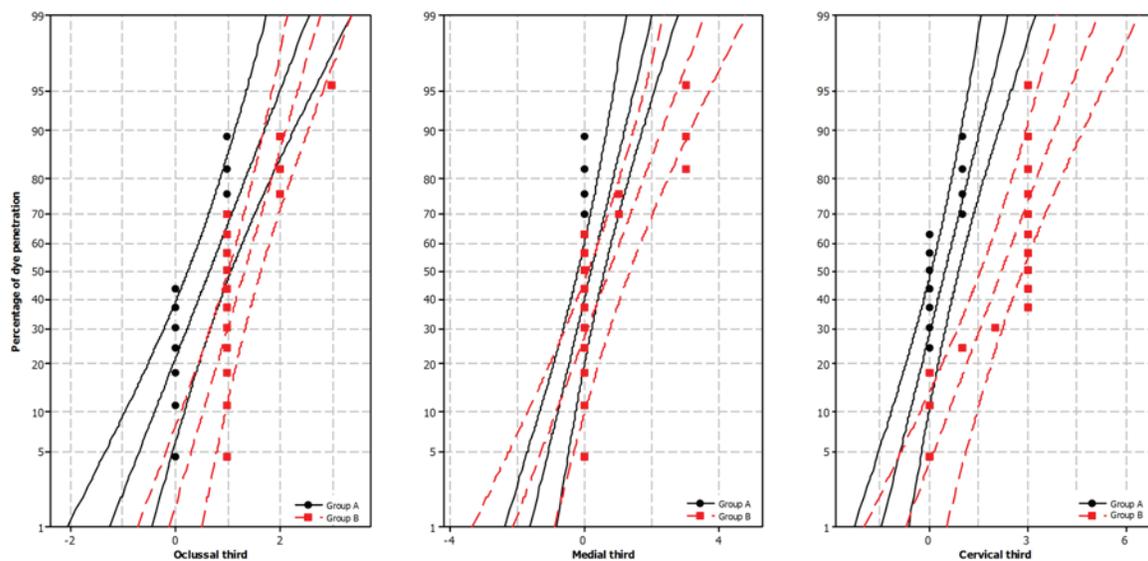
Fig.5. Probability of methylene blue dye penetration into the enamel by thirds in Group A and Group B. It shows the distribution of the data by thirds in Group A and Group B.
